THE ARCHAEOLOGY OF SHORE STRANDED SHIPWRECKS OF SOUTHERN
BRAZIL

A Dissertation

RODRIGO DE OLIVEIRA TORRES

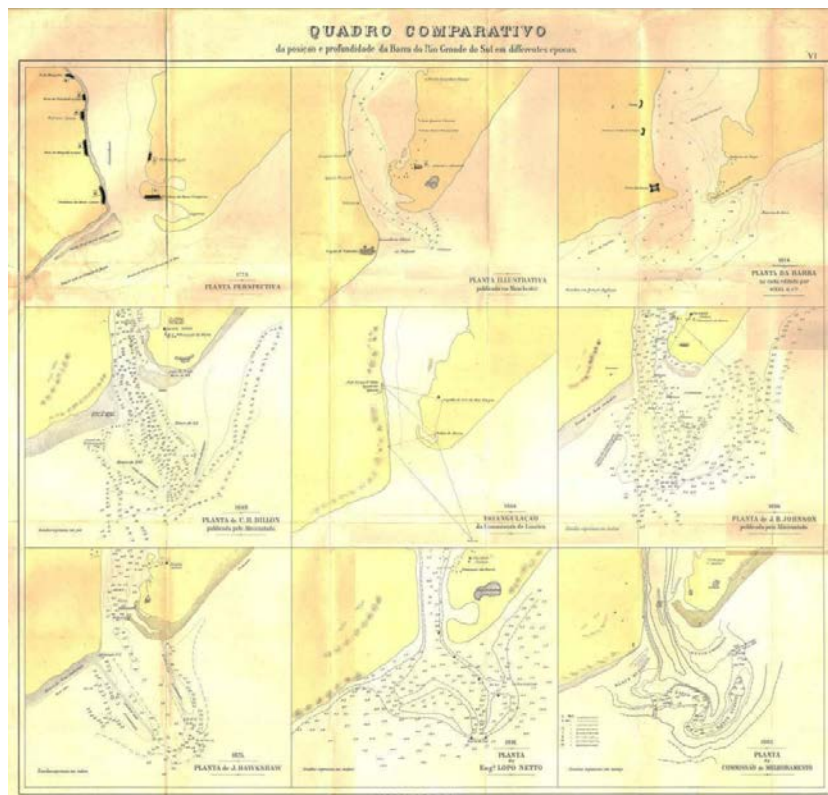
Figure 12. Chart with various surveys of the inlet at the bar, from 1775 until 1883 (Bicalho, 1884: 28).

1866, 3.20m in 1875, and 2.70m in 1883 (Bicalho, 1884). Moreover, the channel position was constantly shifting in response to changing hydrographic conditions, making the passage highly unpredictable and exposing the ships to increased risks during the often severe weather conditions (Figure 12).

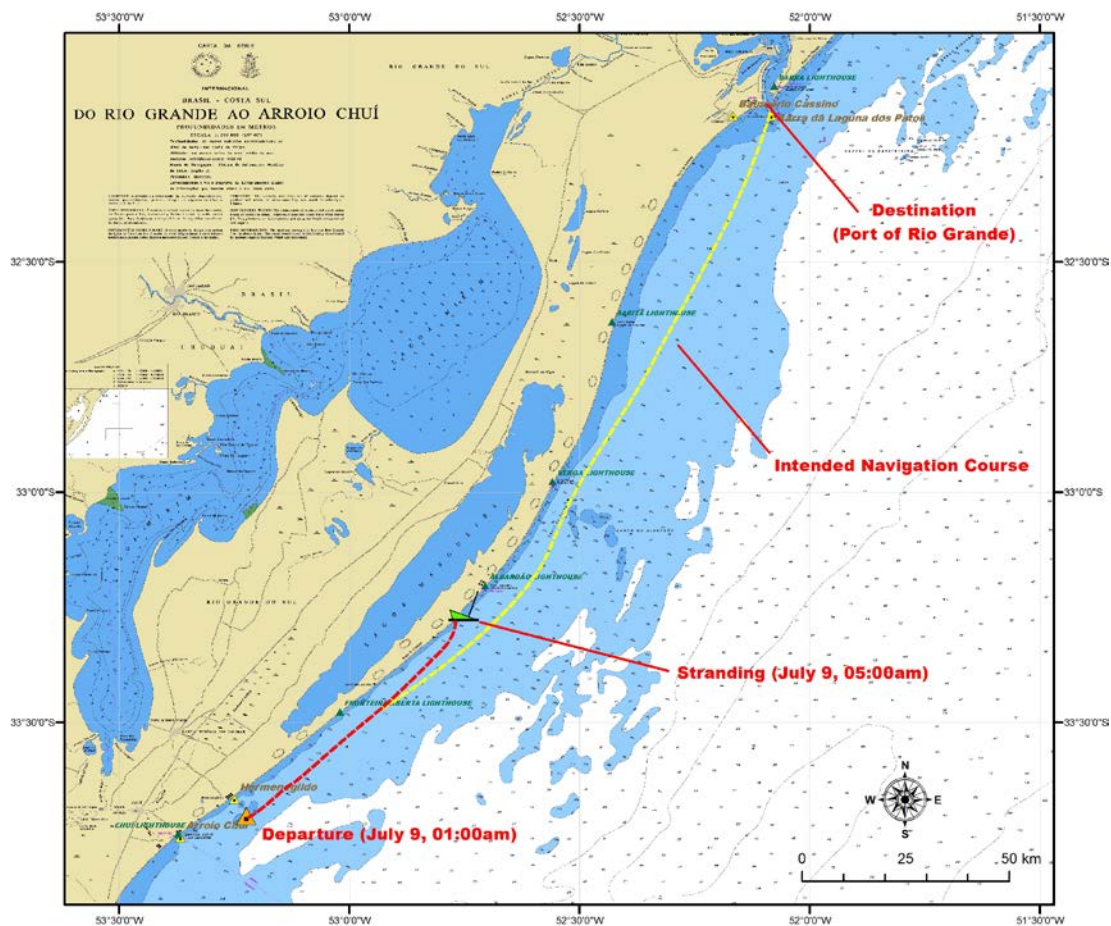
Figure 28. Plotted track of fishing vessel NP *Magalhães II*, showing the stranding location.

seven, the ship left the port of Rio Grande on Sunday, July 6, prepared for fishing over the continental shelf in the rich fishing grounds near the border between Brazil and Uruguay. The small wooden trawler was built in 1978, with an overall length of 13.2m and capacity for 20 tons of fish. It was equipped with PX radio, GPS, and echo sounder, which were all working properly at the time of the accident, according to investigations led by the Port Authority of Rio Grande do Sul (Inquérito Naval, Processo N°. 20.627/03).

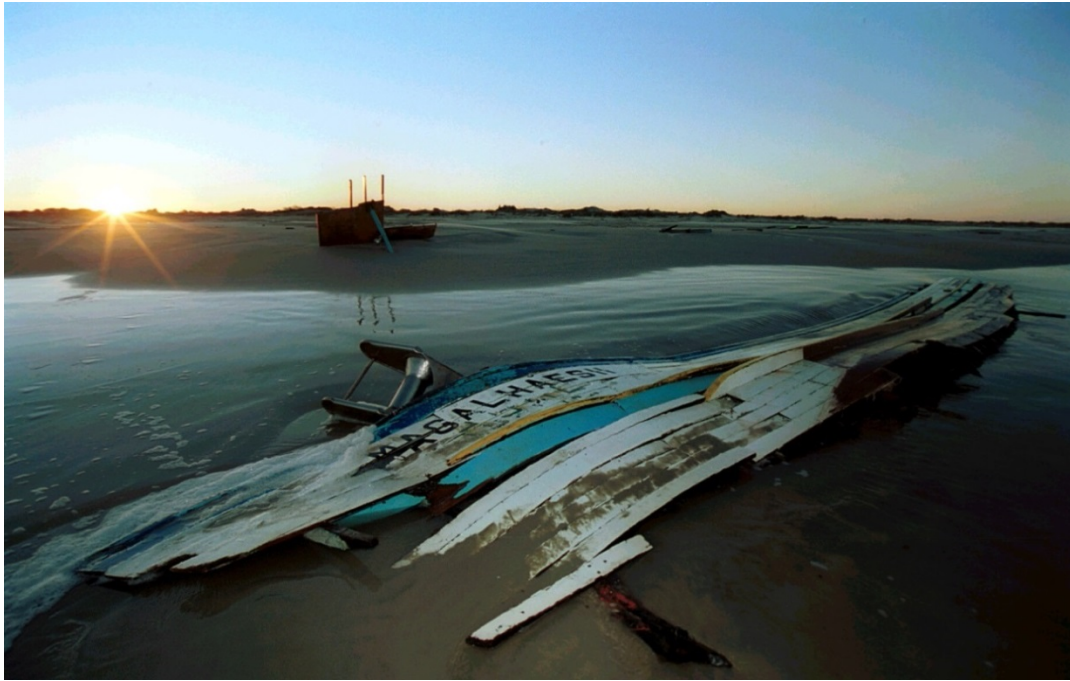
Figure 30. Broken up remains of the fishing vessel *Magalhães II* portside bow, as seen less than a week after the accident (Photo: Flávio Neves).

the Brazilian Navy. Less than a week later, once the sea had receded past the storm surge, the old ship was found totally lost, broken up into pieces spread along the beach (Figure 30).

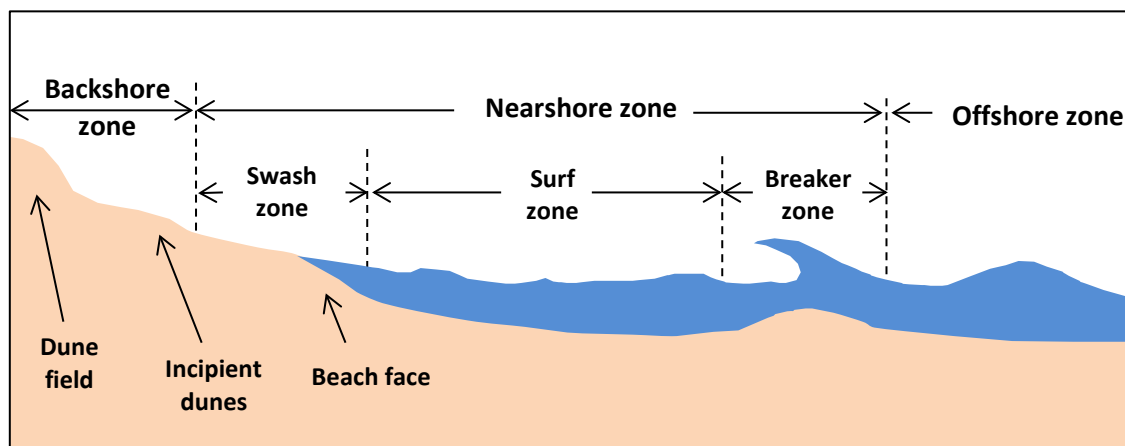
Figure 34. Idealized beach profile (not to scale).

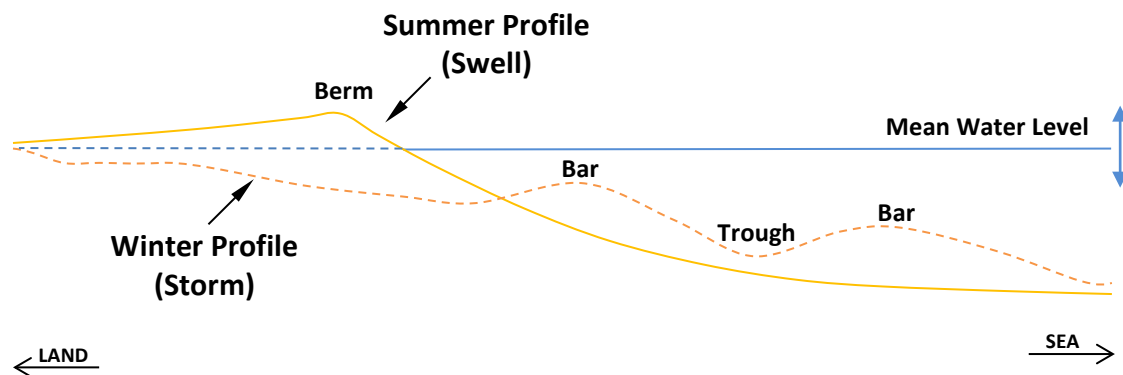
Figure 35. Generalized variations in beach profiles in response to changing energy conditions (Modified from Komar, 1983: 7). Not to scale.

backshore under previously calmer conditions, carrying it away seaward, where it will be reworked by waves and coastal currents into characteristic longshore bars.

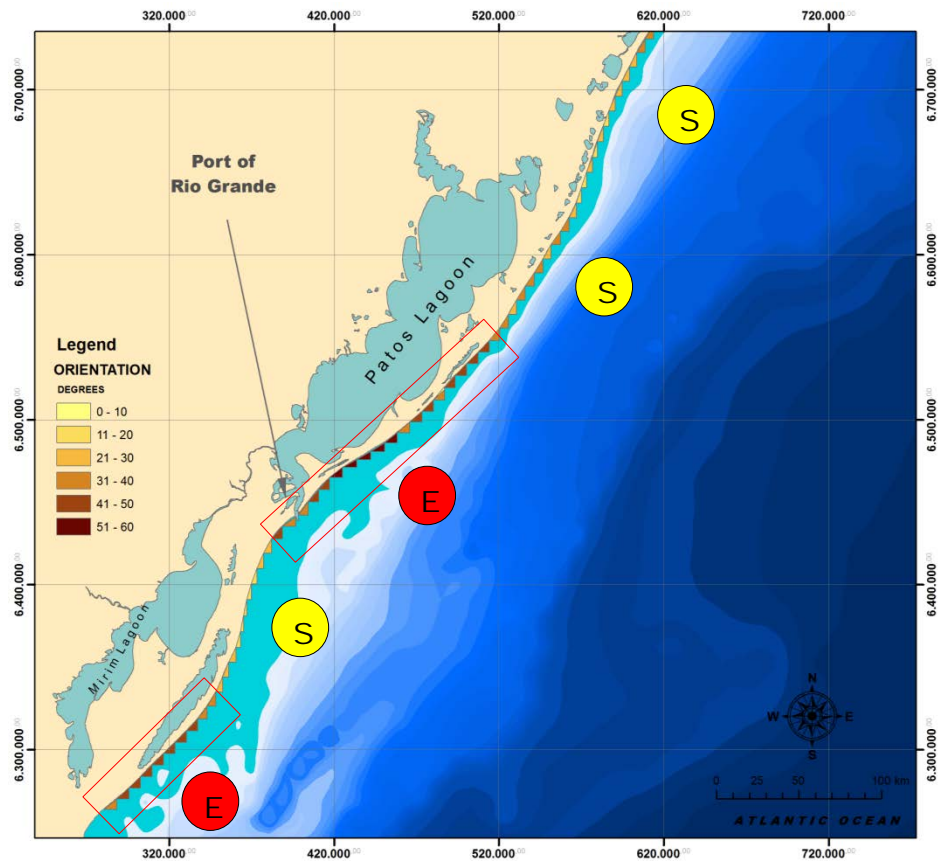
Figure 36. Map with variations in shoreline orientation and erosion data. Red rectangles mark the areas with greater exposure to more energetic wind and waves from the southern quadrants. Red dots mark erosional areas, whereas yellow dots mark stable areas. Beach erosion data from Calliari et al. (2006).

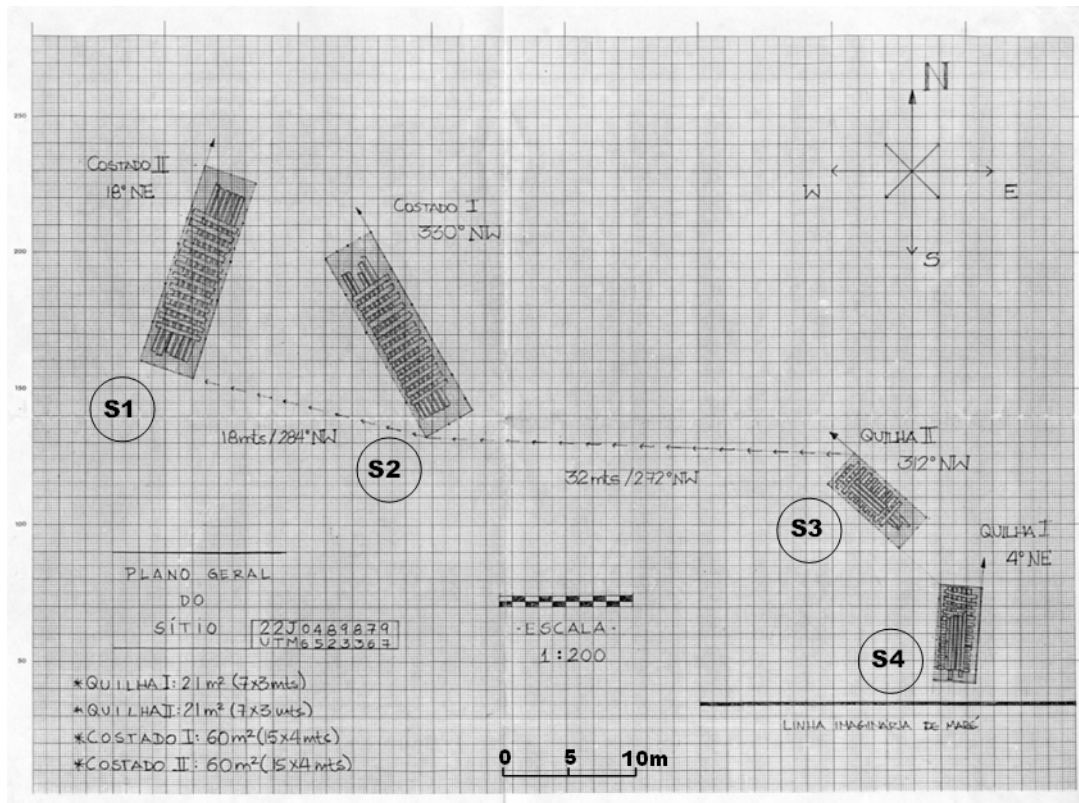
Figure 37. Site plan for NAV Lagoa do Peixe shipwreck done in 2002, showing relative position of the recorded structures.

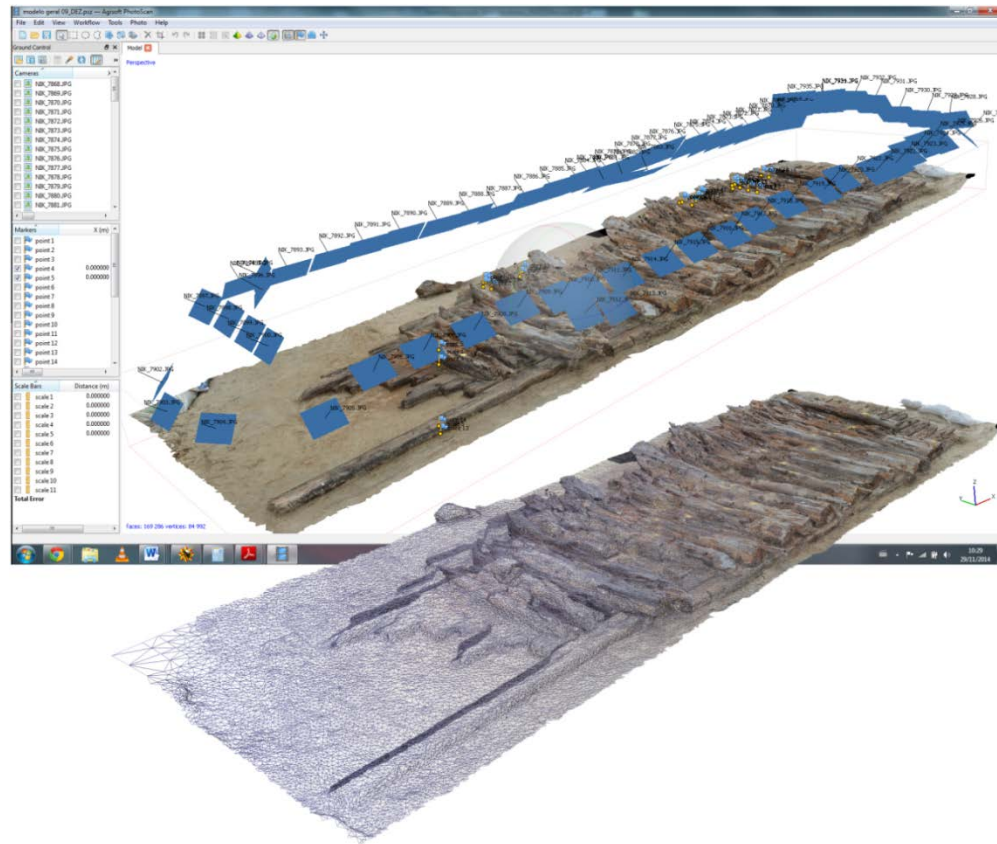
Figure 39. Above, print-screen with software interface showing camera positions (blue squares) for generation of Structure 1 model. Below, a blend of wireframe and textured 3D models.

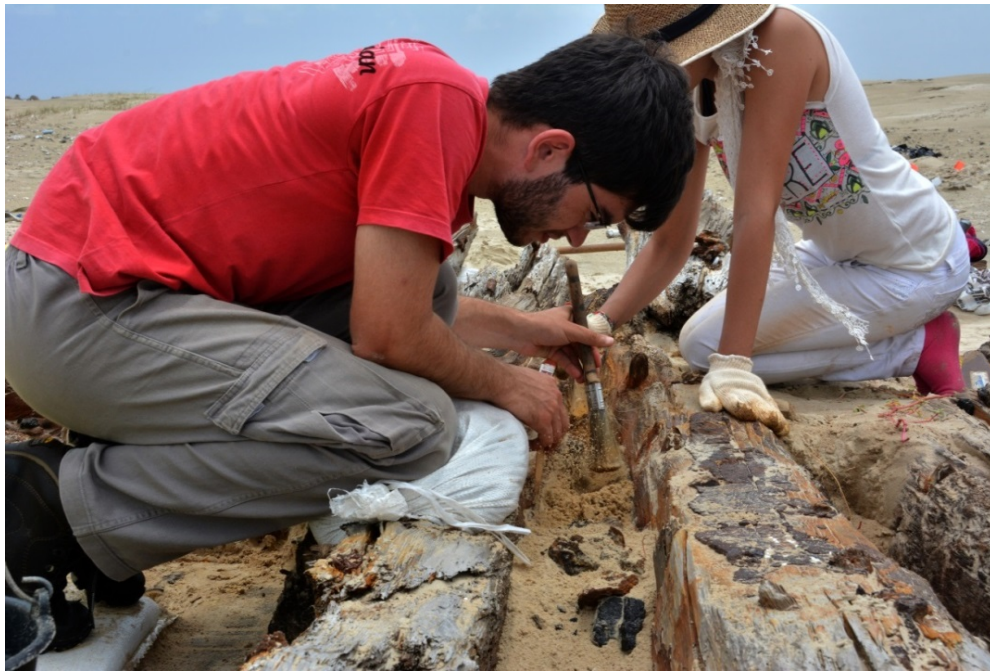
Figure 40. Excavation conditions at the site NAV Lagoa do Peixe.

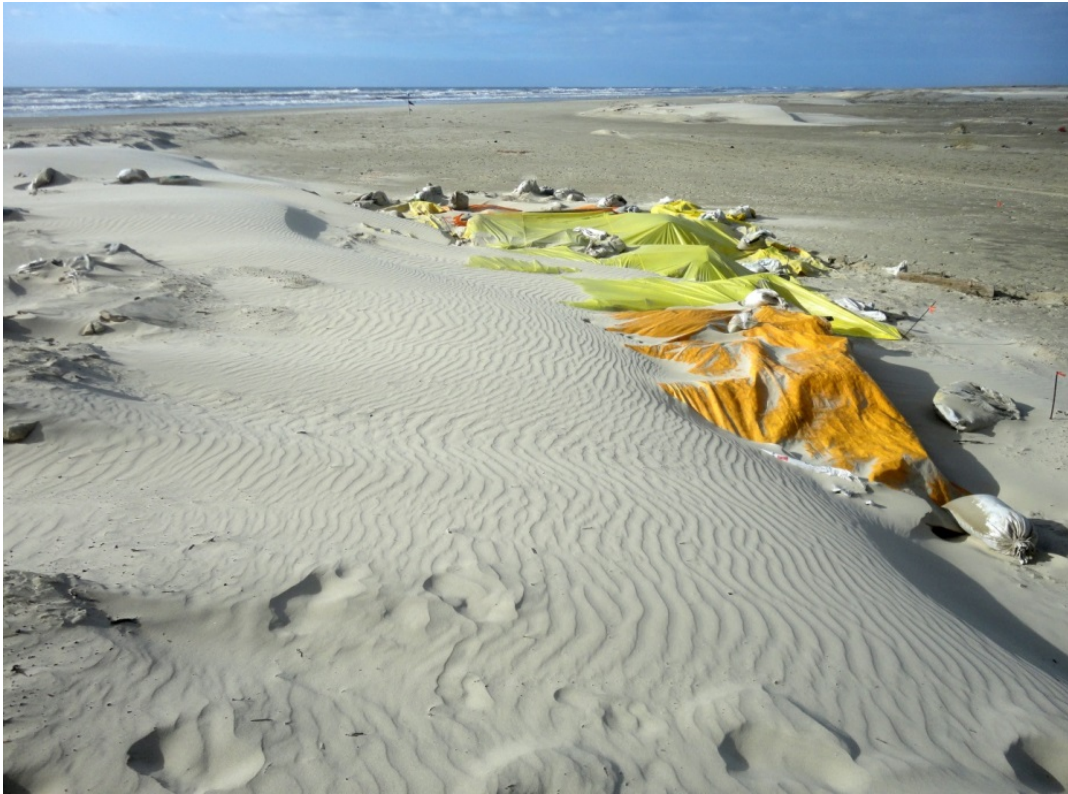
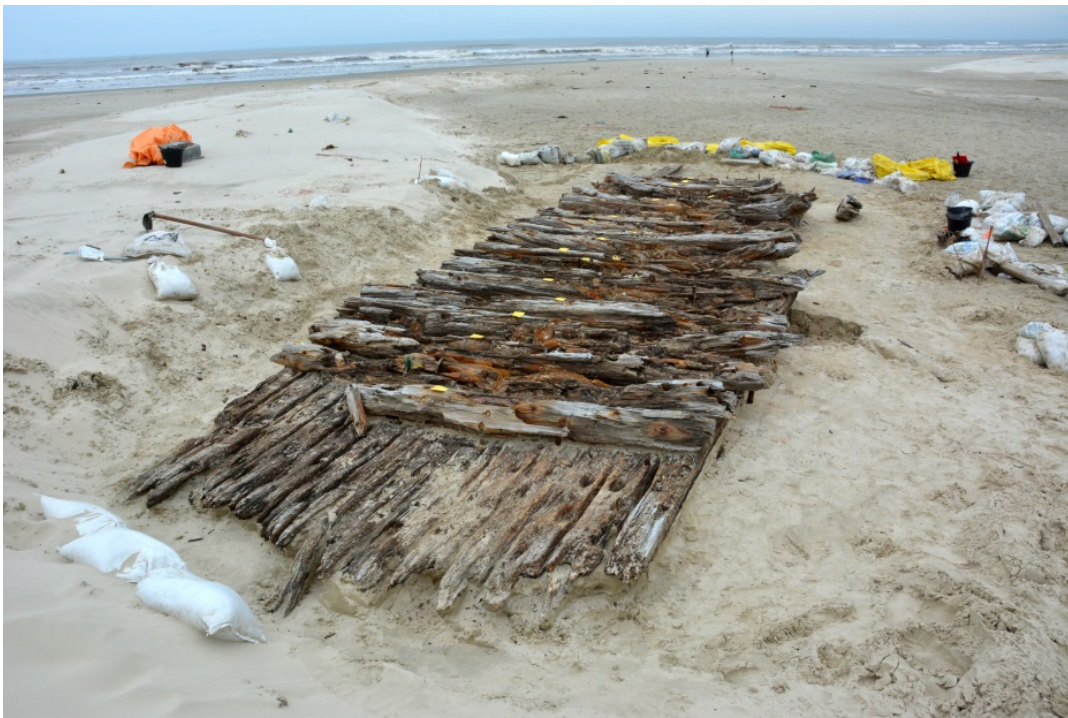
Figure 41. Above, protection against shifting sand. Below, situation of Structure 1 once completely excavated.

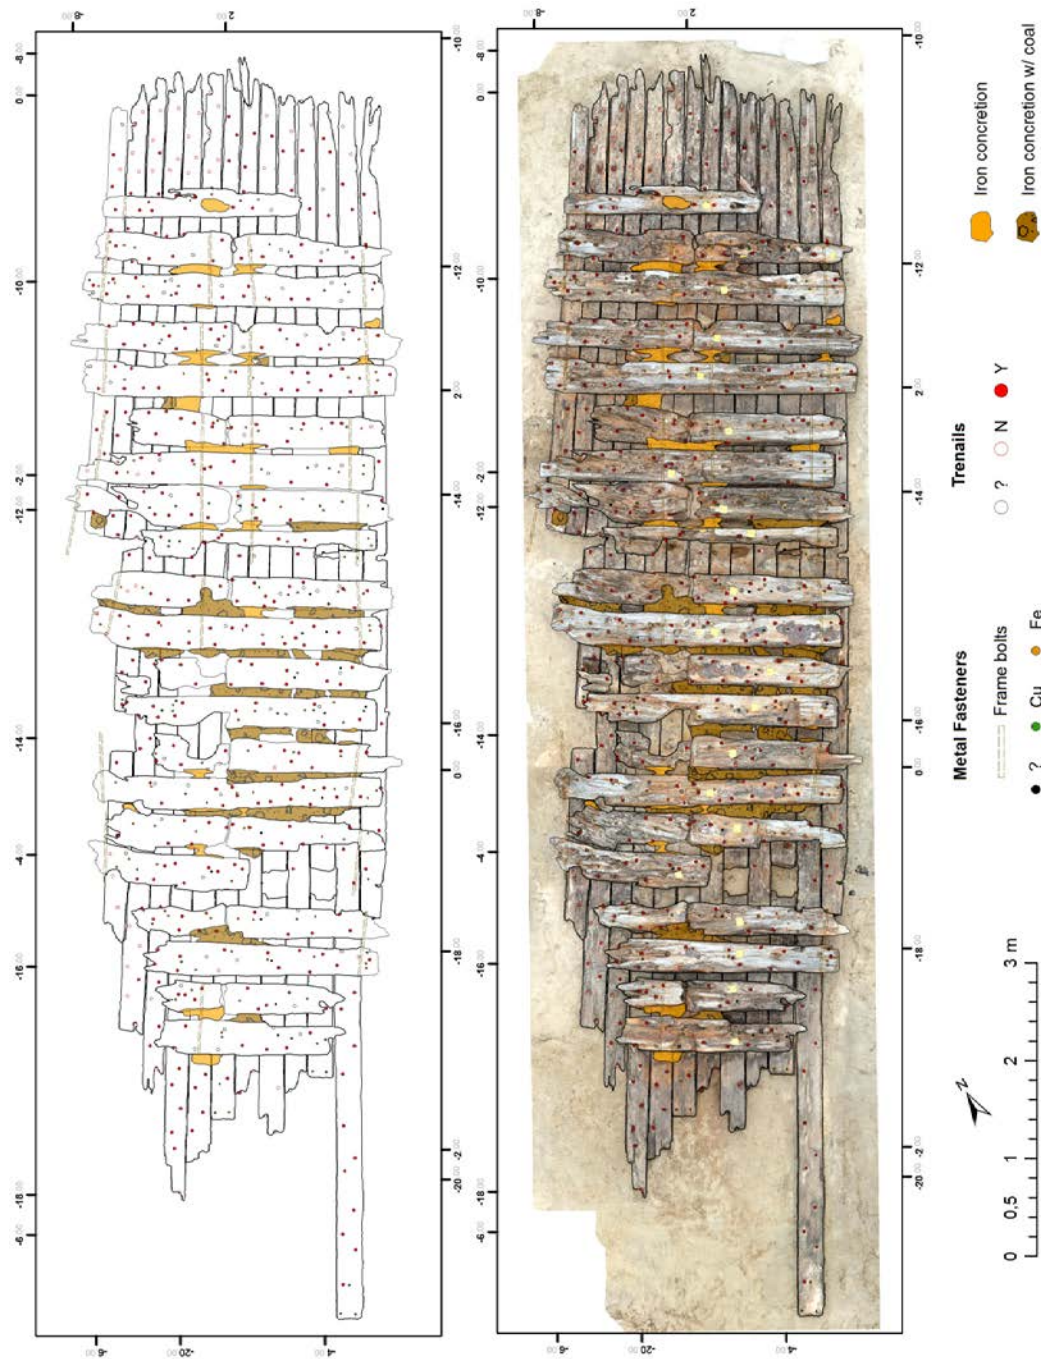
Figure 44. Structure 1. Left, outlined plan of frames and planking, treenails, metal fasteners and concretions. Right, same plan but backed by an orthophoto.

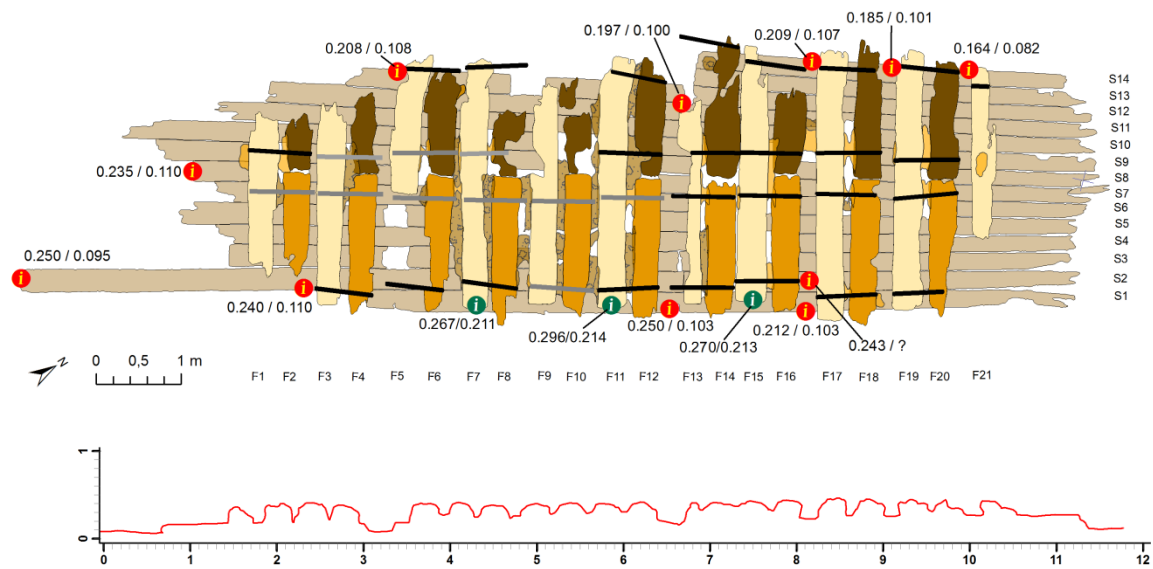
Figure 45. Outline of Structure 1 showing scantling measurements on preserved surfaces of frames (green) and planks (red), first number for sided dimension, second for molded dimension, in meters. The position of observed longitudinal iron bars are in bold black, and other positions suggested by concretions are in gray (thickness exaggerated for visualization). Below, a longitudinal profile.

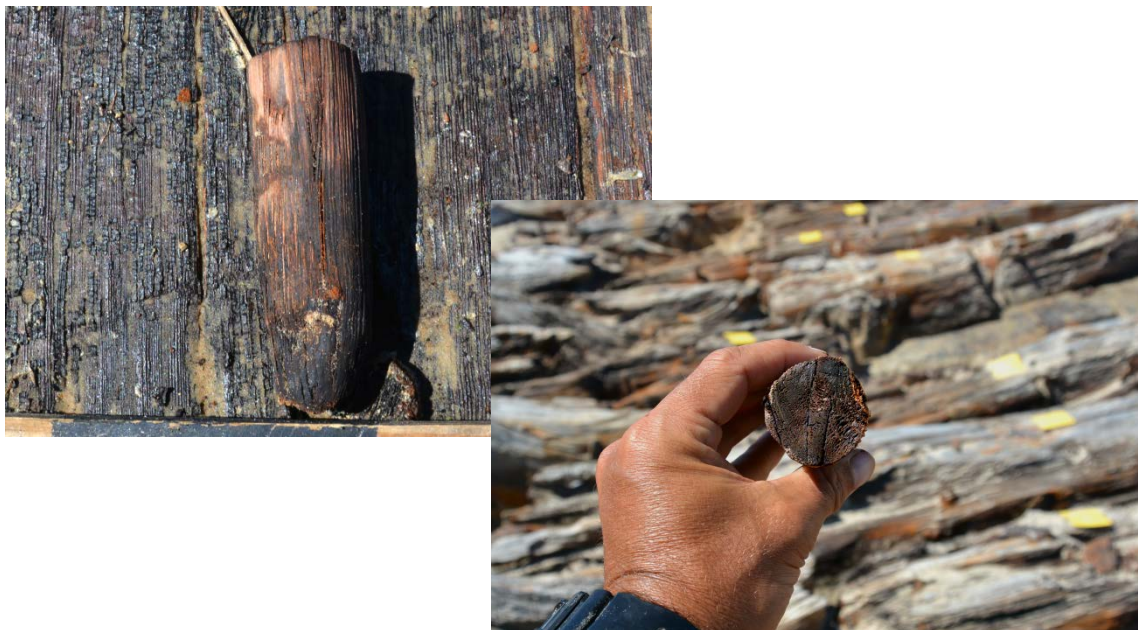
Figure 46. Treenail piece from strake 7, showing wedged end.

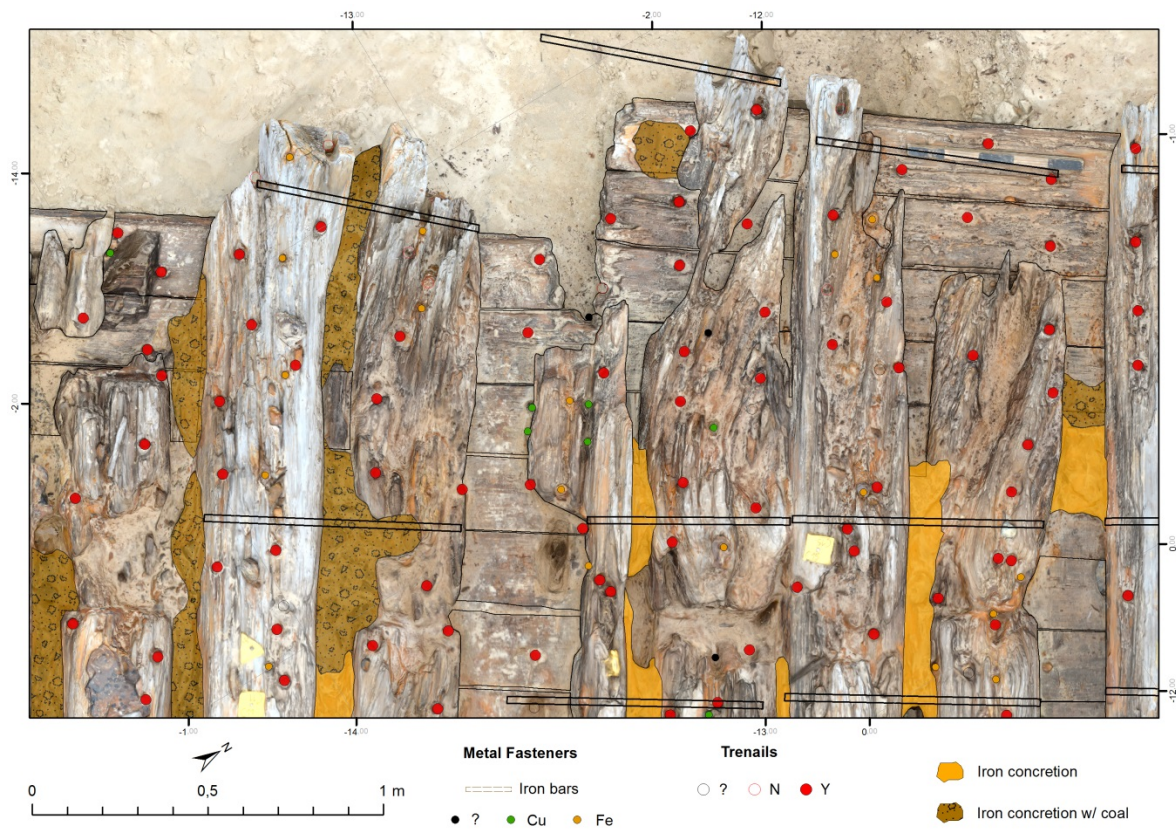
Figure 49. Distribution of fasteners.

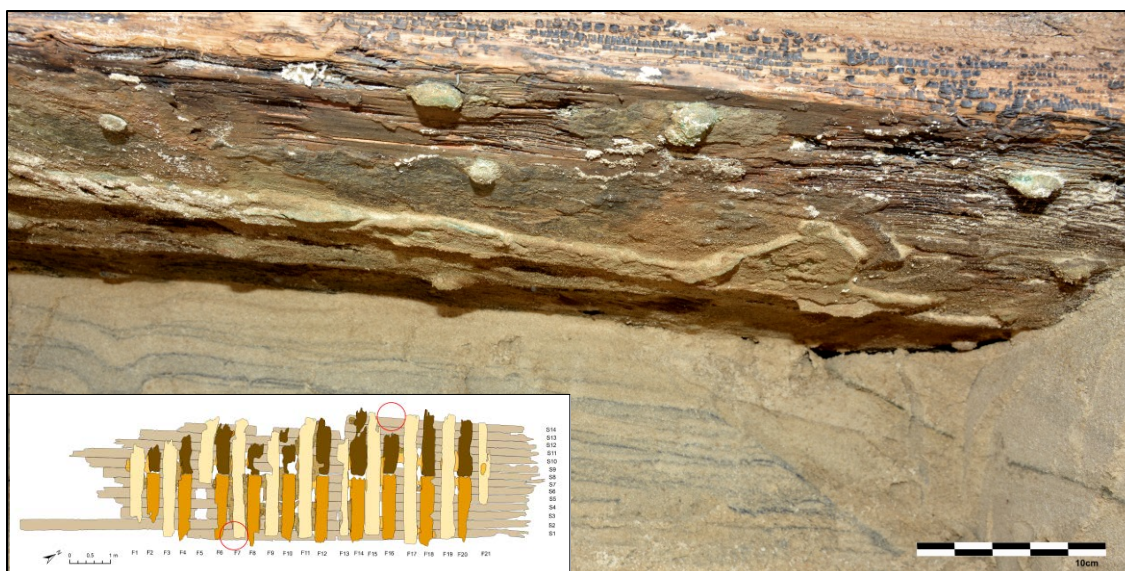
Figure 50. Evidence of metal sheathing on the underside of strake 14, in between frames 16 and 17. In the detail, the two points where metal sheathing was observed are marked with red circles.

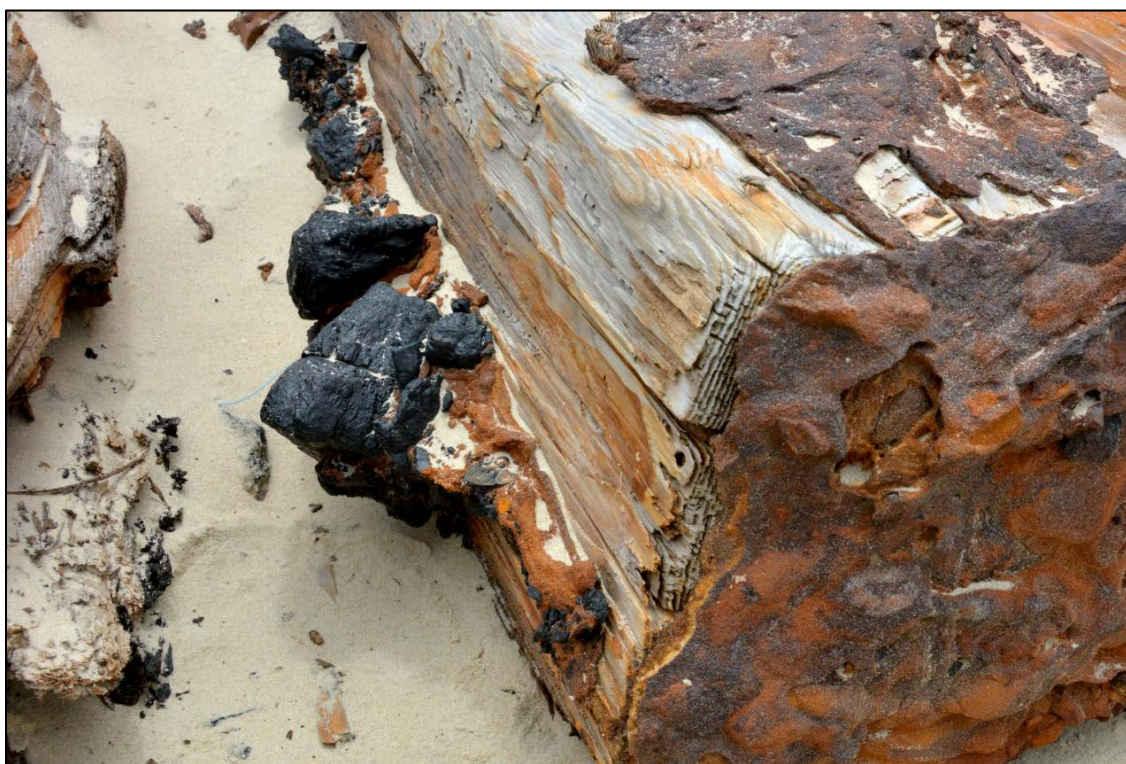
Figure 51. Evidence of coal as part of the ship's cargo adhered to a concretion on frame F11.

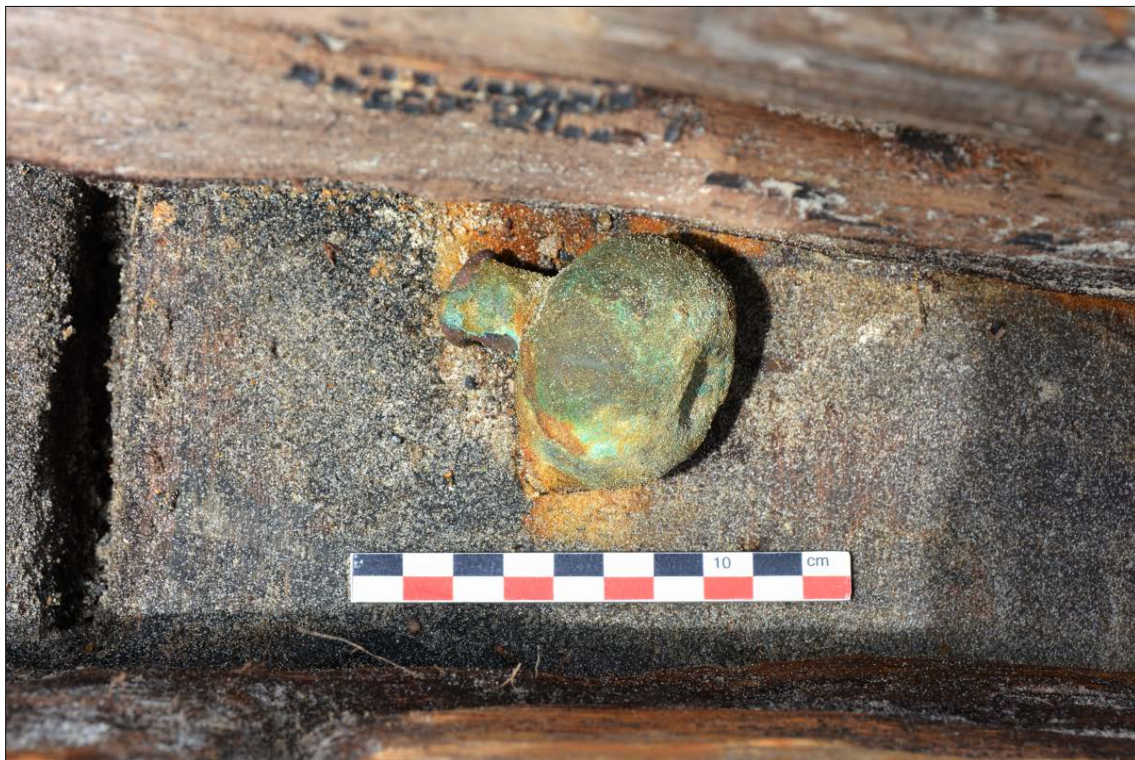
Figure 52. Brass knob as found after excavation in between frames 2 and 3.

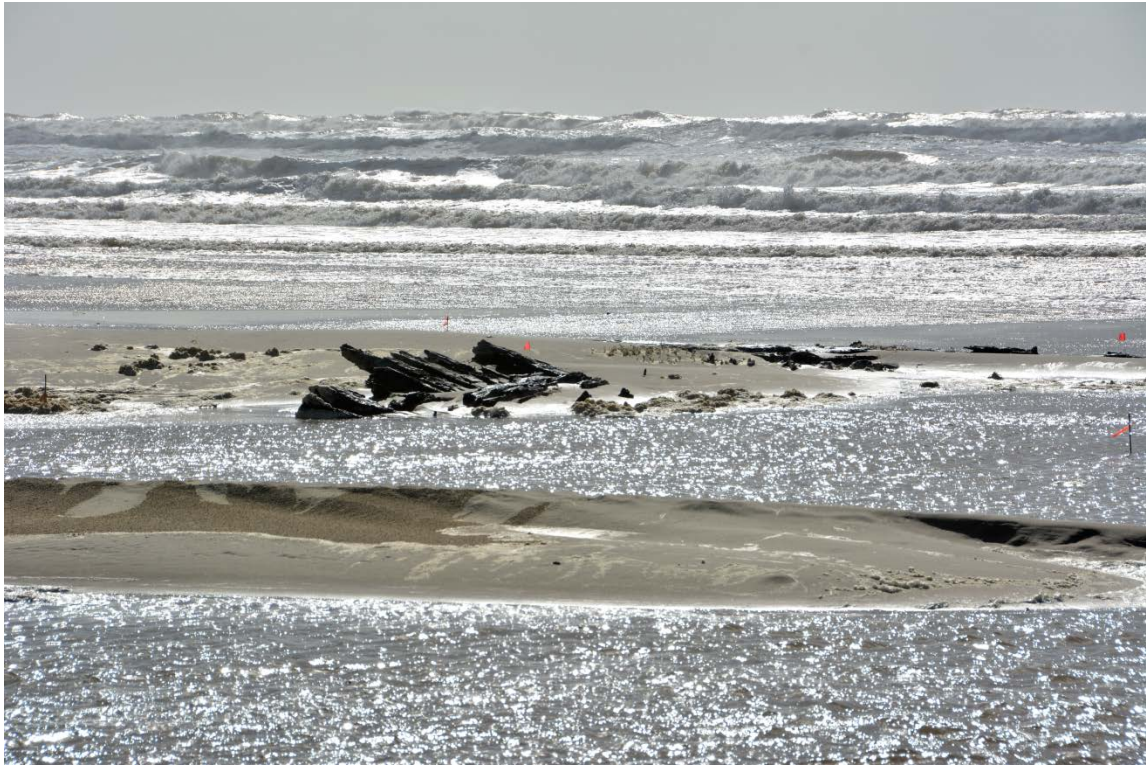
Figure 54. Situation of Structures 3 and 4 during a storm surge which reached the area during fieldwork in 2013.

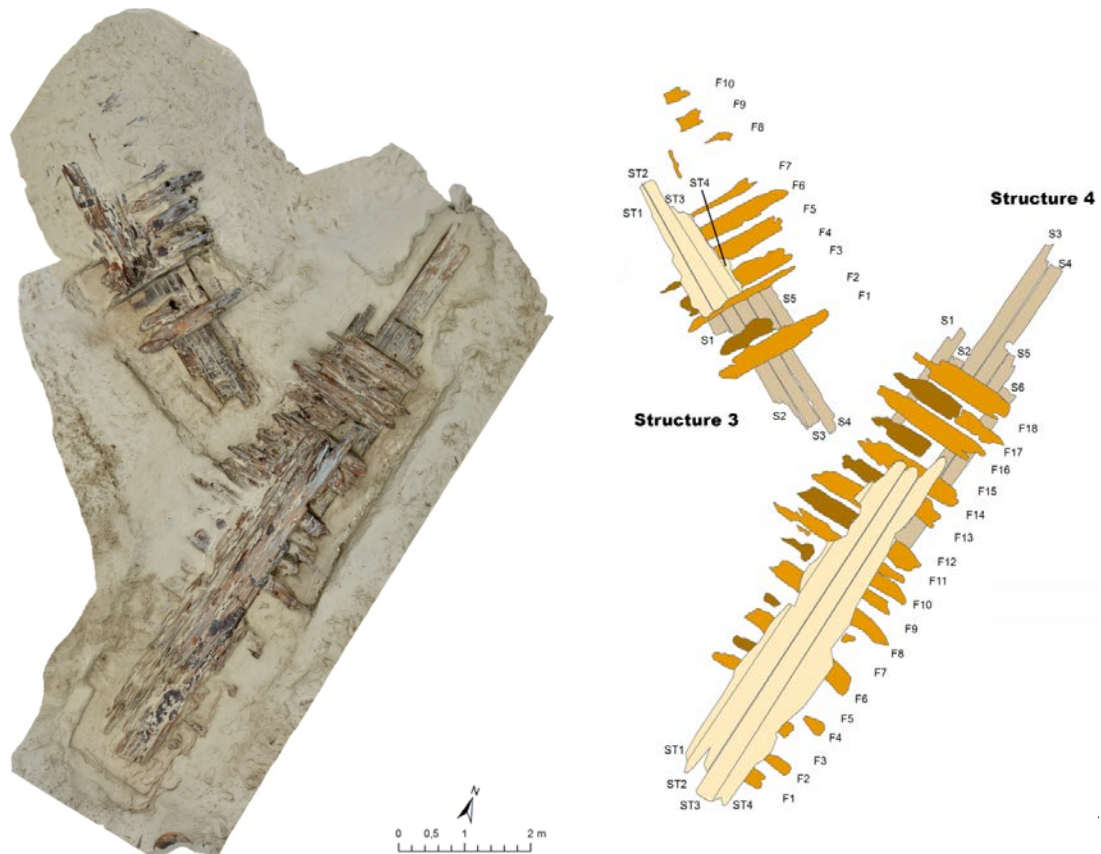
Figure 55. Orthophoto (left) and tagged outline (right) showing relative position of Structures 3 and 4, as found during excavations in 2013.

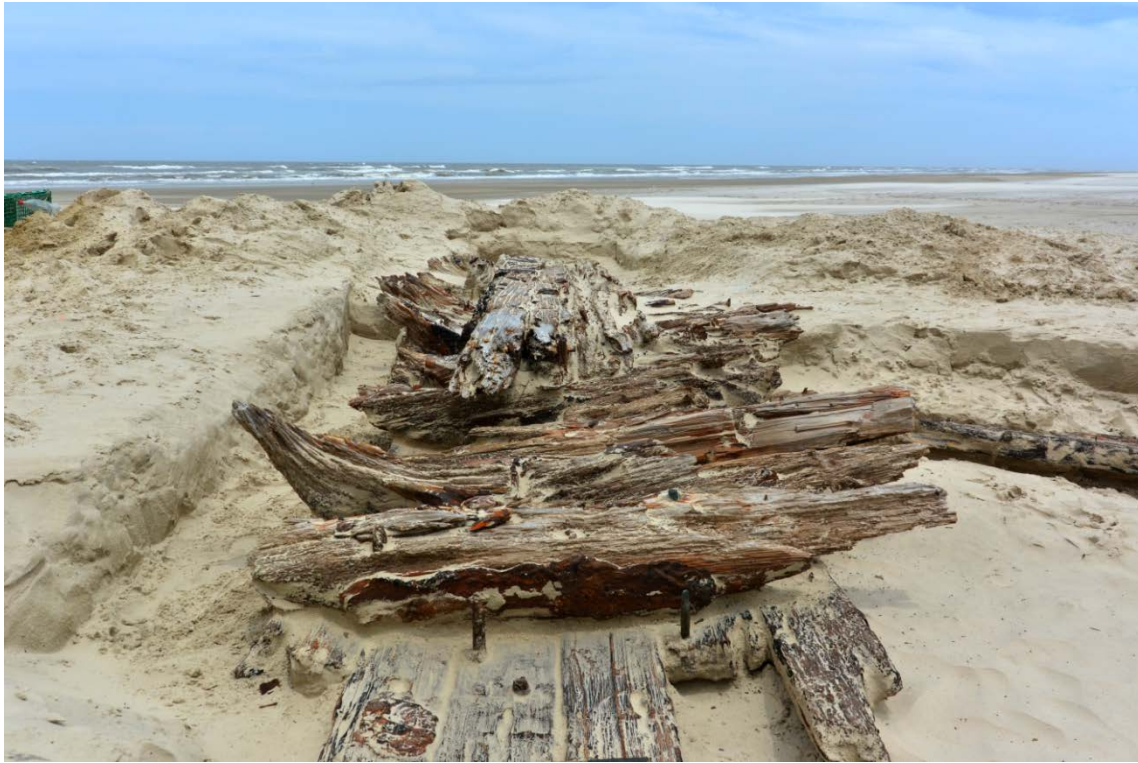
Figure 56. Structure 4 showing the position of planking, frames, bilge stringers and frames curvatures.

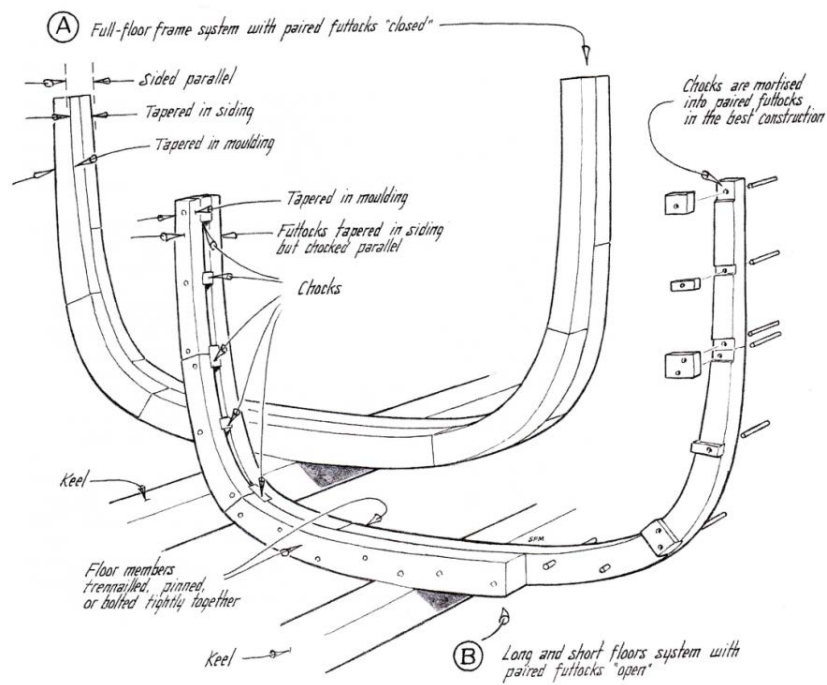
Figure 58. Schematic drawing of the two abovementioned composite double framing assemblies (modified from Greenhill, 1988: 114).

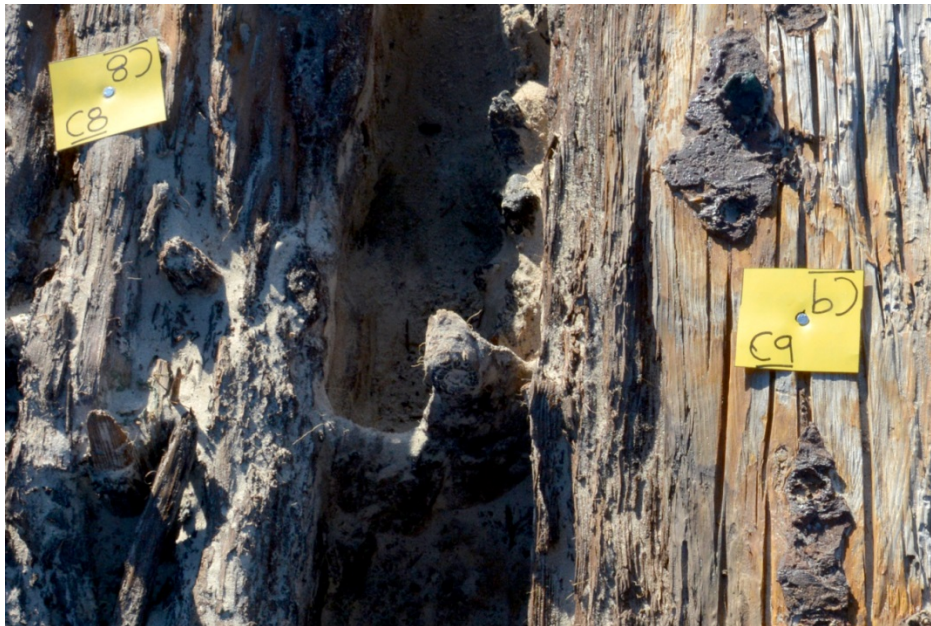
Figure 59. Detail of a possible chock found in Structure 1 between frames 8 and 9.

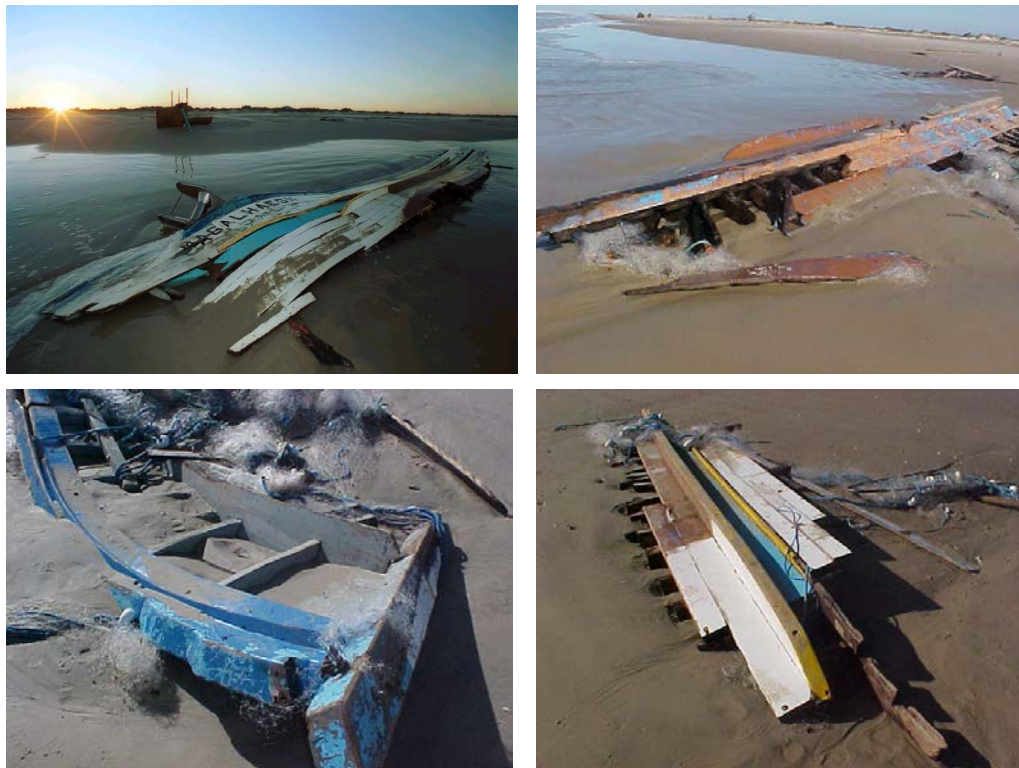
Figure 61. Pieces of the *Magalhães II* hull, as found a week after the accident (Photos: Flávio Neves).

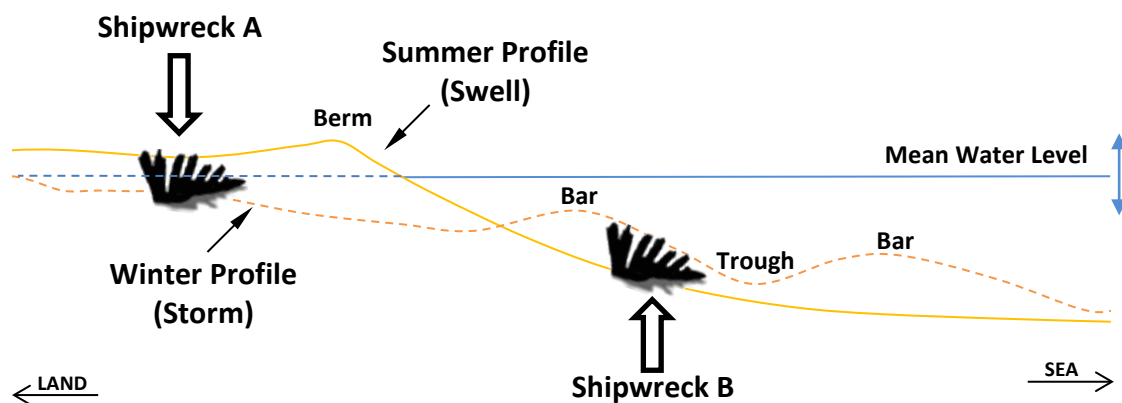
Figure 62. Generalized variations in beach profiles in response to changing hydrodynamics within the active zone of beach profile (Modified from Komar, 1983: 7). Not to scale.

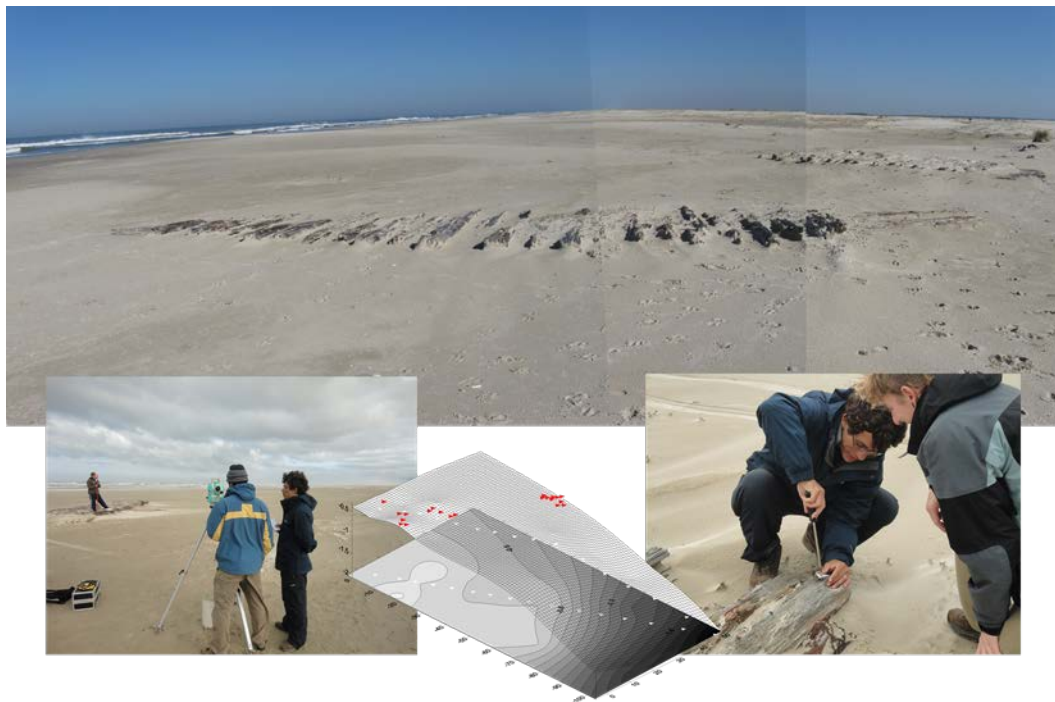
Figure 64. Monitoring experiment started in 2011 at the NAV Lagoa do Peixe site.

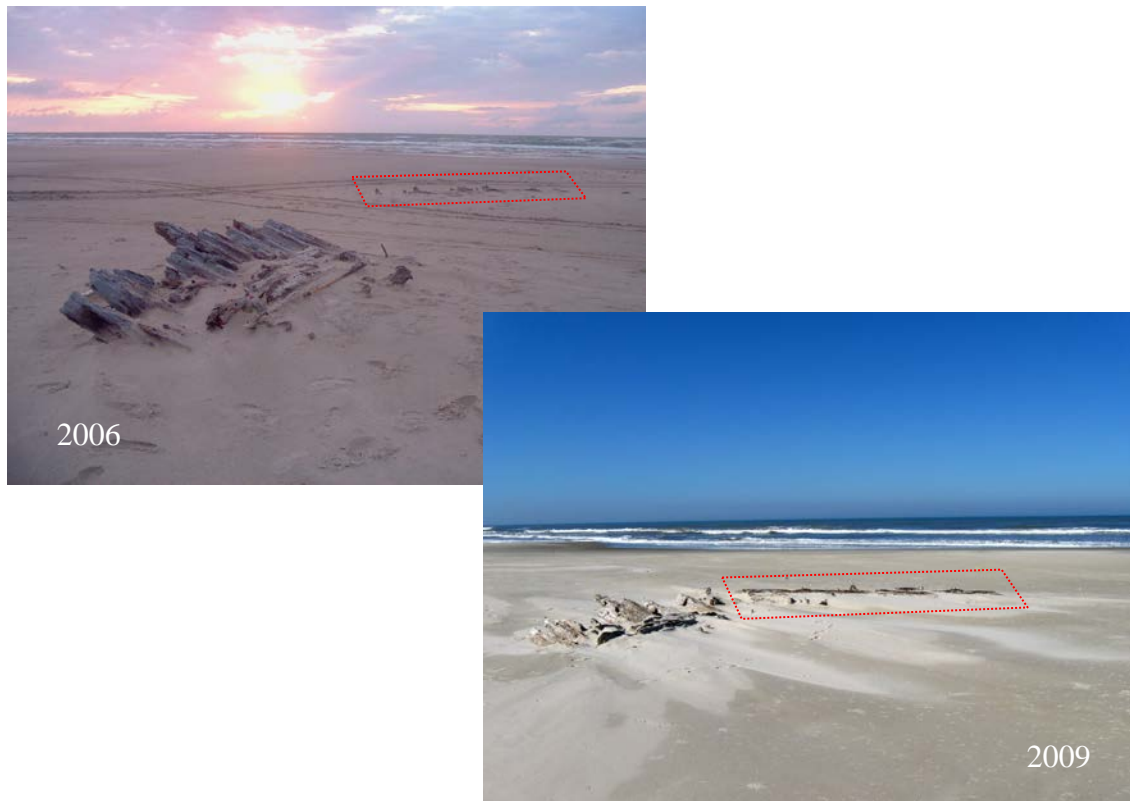
Figure 65. Structures 3 and 4 photographed in 2006 and 2009, showing relative displacement of structures 3 and 4 (dotted red rectangles).

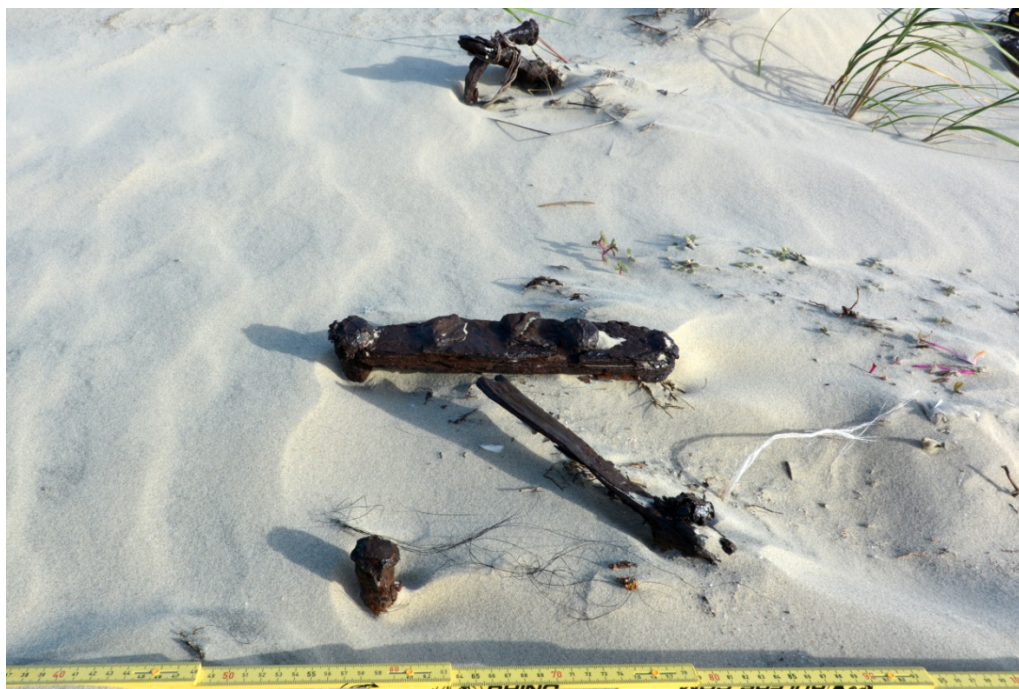
Figure 75. Naturally exposed iron fasteners observed at the NAV Inédito B site in 2013.
